Management and Maintenance of Public Outdoor Sculpture in Nigeria: An Example of Oduduwa Statue Restoration in Ile-Ife

¹Akintonde, M. A., ²Oladugbagbe, F. E. A.

Department of Fine and Applied Arts, Ladoke Akintola University of Technology, Ogbomosho
NIGERIA.

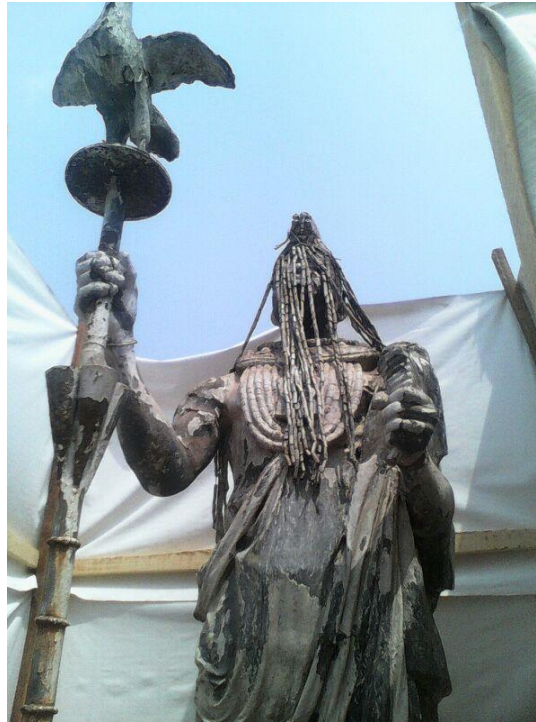
Plate 1: *Statue of Oduduwa* screened for the restoration exercise. Photograph by Moses Akintonde, 2015

Oduduwa was said to have been renovated always by road side artist-a sign writer according to *Sarun Ooni*, Oyelami Awoyode - the head of palace servants. Over the years, the gloss paint used for the painting of the work had gradually accumulated into a thick hard surface on the work. As a result of harsh weather intense heat and high humidity impact, abrasion processes in the work became steady. Invariably, the accumulated paint developed cracks at the convex points. These actions further allowed rain water to percolate through the cracks and strained the fibre glass walls to bloat and burst, degenerating into eventual rots in some parts of the statue. The problem further set in motion chemical reactions in the water contents always stored in the walls which also triggered biodegradation process on the statue through fungi growth, heightened by lizard and wall-gecko wastes and their other activities observed in the cracks and grooves in the works.

Added to the rapid process of disintegration of the work was the poor use of material for certain portion of the statue. For examples the major parts of the image was made of polyester resin but the strings of bead attached to the crown was made of young bamboo stem, a material which is susceptible to cracks due to harsh weather pressure. The staff held by the right hand (plate 9) was also made of galvanised pipe. The direct contact between the two forms (one a fiber material, the other a galvanised metal) definitely yielded to pressure, generated by cold and hot weather induced contraction and expansion. Arising from this actions, the staff made of galvanize pipe, evidently pull the fiber hand usually during expansion on sunny day heat. It releases it again at the cool of the night. The continual pressure on the hand, invariable broke apart the fingers of the image's right hand. The wrist and the upper arm at the scapula joints were also broken (plate 10). The entire arm was loosely held together only by few fiber yarn and a corroded tiny metal armature.

Restoration work started on the statue by January 20, 2015 and did not complete until February 24, 2015. The work was done in stages for proper technical management. First, the thick layer of accumulated surface color from previous renovation and fungi growth were removed. Some problems were experienced in the removal of the crack color. On thorough observation the thick accumulated color on many parts of the statue still cleft strongly into the fiber glass walls of the statue, by capillary attraction starting from the first coat of gloss color used on the image during the various renovation exercises. Subsequently, it built up gradually and in some cases, filled up cavities in the forms of the image, as well as the surface texture recesses; which grew up as much as 1.00mm in the concave areas of breast bead and thread lines; about 2.1mm at the convex and as much as 3.0mm at the cavities in the recesses of the fold, clavicle bone region *etcetera*.

Local gloss color solvents were initially thought to be appropriate for the removal of the thick layer of the surface color of the image. However all solvents applied failed, due to the degree of thickness and hardness of the layers of color. The option of solvent or acid wash was dropped as the former only had little effect in the removal of the color pigments; the later however might severely damage the fiber walls.

In order to retain the delicate forms and the textural effect in the work, gradual scarping and flaking off of the color was employed. The color pigments were flaked off gently by tapping with small scrapper edge on the surface of the image which induced cracks and flakes in the accumulated color, especially along the contour lines. The pigment was carefully detached off or scrapped until everything was removed; the left over in the cavities were difficult to remove. But little gentle tap by a light hammer on such area with chisel successfully removed the pigments in the recesses.

All the broken seam lines, cracks and torn fiber walls were remoulded with jell-coat polyester resin mix. The badly disintegrated right upper hands at the ball and socket scapula joints were remoulded. The cracked elbow joint and the fingers that had broken some months earlier were remoulded. The broken beads at the base of the lower part of the crown region (plates 10 and 11) were put in place. Fifty strings of 75cm length of beads were made and used to replace those that have been disintegrated.

The head of the cockerel, a part of the composite statue, which had been completely detached was also remoulded. The rust gongs on the metal staff held by the image were also carefully grinded and kept in proper shape. The entire surface of the statue was washed and allowed to dry before two coat of an auto-based white gloss color was lightly sprayed on it. The pedestal of the statue were repainted in their former cream color and deep blue lining on the upper and the lower parts of the structure. The fence in the statue environment was also painted while the walk-ways were re-constructed.

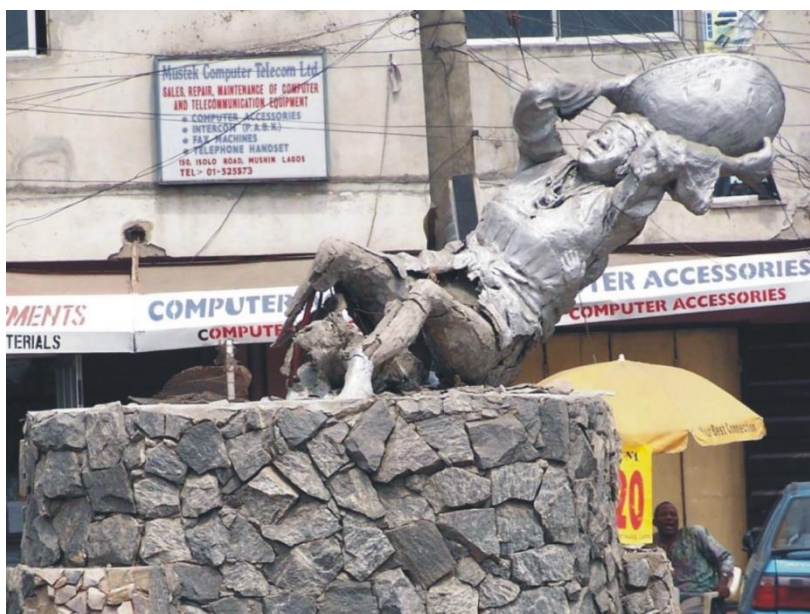
Plate 2: *Iya Oye*, located at Olu Aina Street, Isolo, Lagos The statue fell and remained in the same position for over two years. Photograph by Moses Akintonde, 2007

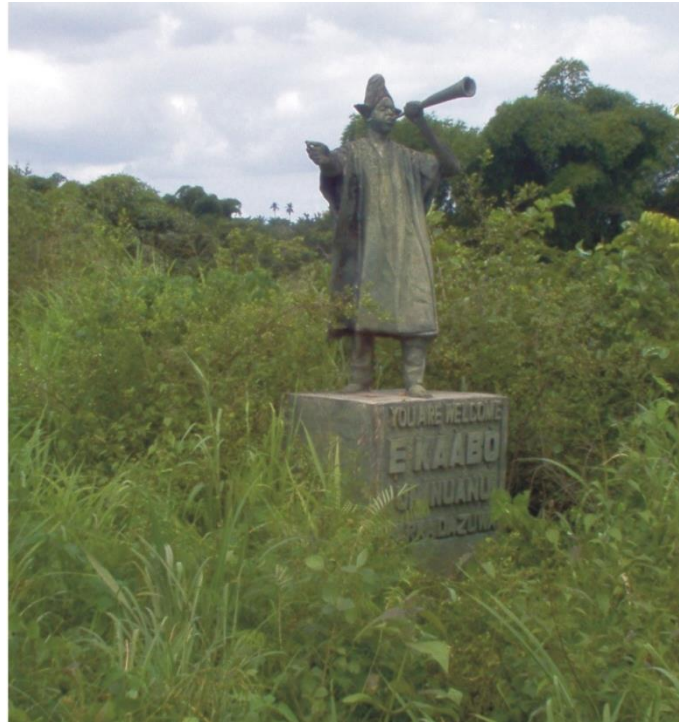
Plate 3: Trumpeter, one of the statues in Osogbo formally maintained by Osun State Capital territory Development Authority now neglected. Photograph by Moses Akintonde, 2009.

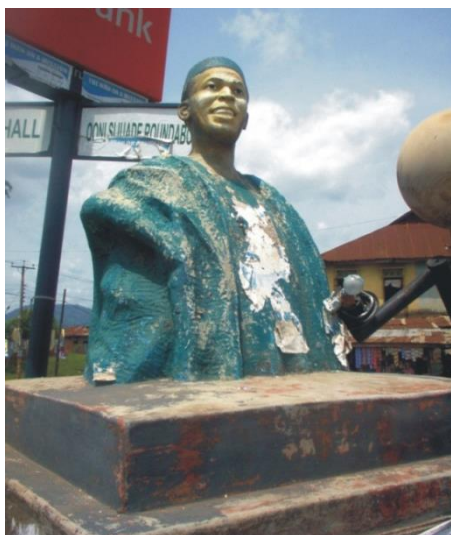
Plate 7

The color effect on statues being renovated is usually awful and repulsive; degrading the aim and the entire processes for which monuments were produced. Public outdoor sculpture images in Ile-Ife such as: *Awolowo* (plate 7), *Moremi*, *bust of Oduduwa*, and statues of *Oduduwa* (plate 1) have been so treated. So were the statues of *Agbe*, and *Iya'la* (plate 8) ineptly renovated in Ila-Orangun. The *Unknown Soldier* at Bode Osi, *Iba Oluyole* in Ibadan and *Alago Oba* in Abeokuta *etcetera* were also poorly renovated. Apart from this, the accumulation of paints used in the renovation of statues over a long period of time usually occasioned strains on the walls of images made with polyester resin due to abrasion caused by contraction and expansion effect of high humidity and excessive tropical Nigeria heat.

The unprofessionally renovated,
Awolowo bust, Enuwa, Ile-Ife.
Photograph by Moses Akintonde, 2013

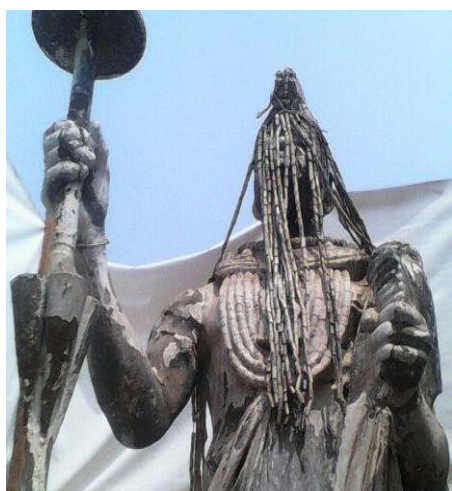
Plate 9
Oduduwa staff made of galvanize pipe
Photograph by Olaleye Olaoye, 2015

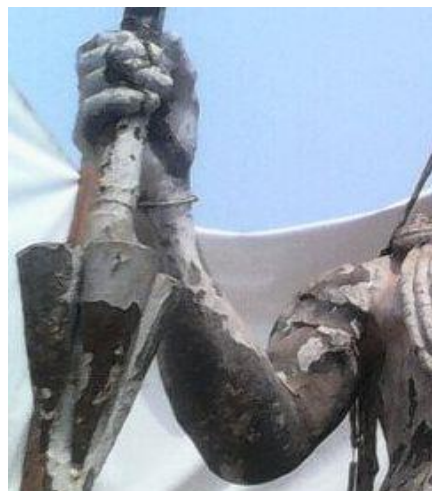
Plate10
The broken right hand fingers, wrist
and the upper arm of *Oduduwa*
Photograph by Olaleye Olaoye, 2015

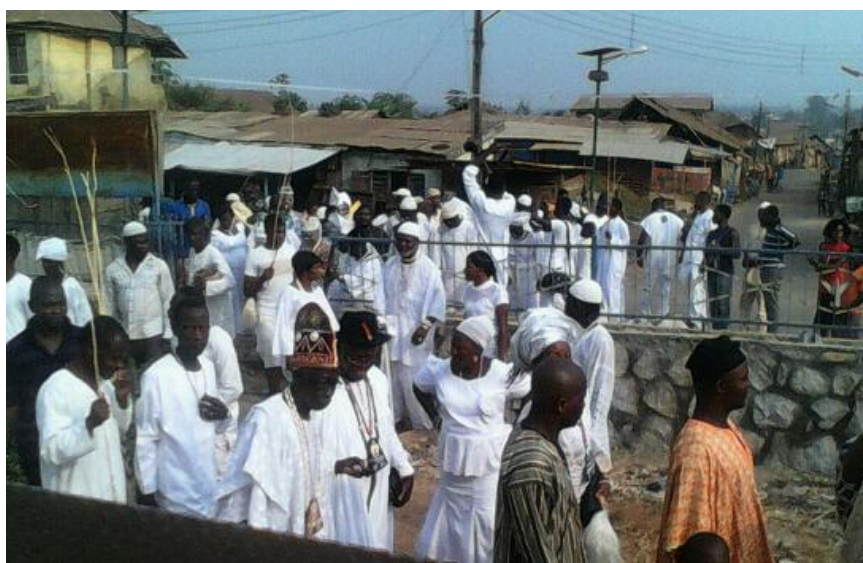
parties and ritual ceremonies. Street orphans who usually mill around the image also, often abuse it. Left-over of food items, each time a ceremony (plate 11) was held in the environment has been noticed on the pedestal of the statue. Ritual materials have also been occasionally left on the lower part of the image.

Plate 11: Obatala ritual ceremony session around the statue of *Oduduwa*. Photograph by Olaleye Olaoye, 2015

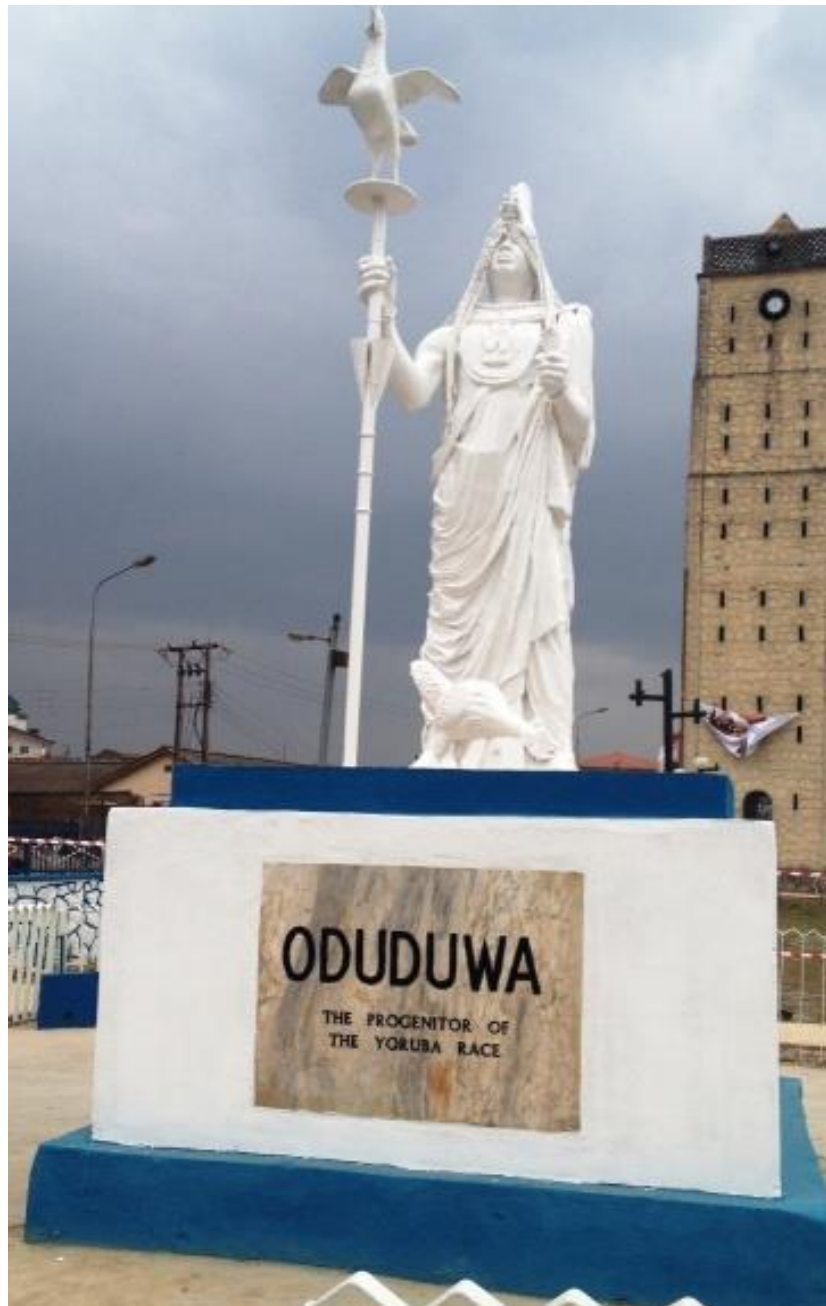
The restoration work was carefully made to bring the work to its former state (plate 13). The main problem is the surface texture which had reduced a little in quality. The accumulation effect of previous color pigment had eaten deep into the fiber wall of the statue. The abrasive effect on the surface texture over time had also weakened it. When the colour pigment layer was removed, some delicate textured forms had become powdery and flaked. Even, at the crown area where not much color pigments accumulation was notice; its surface had been gradually eroded. As a result of this, the intricate beaded crown decoration form had reduced in value. Despite the loss in tactile quality of the original image, the restoration exercise

Plate 13: The successfully restored Oduduwa statue. Photograph by Moses Akintonde, 2015
