Management and Maintenance of Public Outdoor Sculpture in Nigeria: An Example of Oduduwa Statue Restoration in Ile-Ife

¹Akintonde, M. A., ²Oladugbagbe, F. E. A.

Department of Fine and Applied Arts, Ladoke Akintola University of Technology, Ogbomosho
NIGERIA.

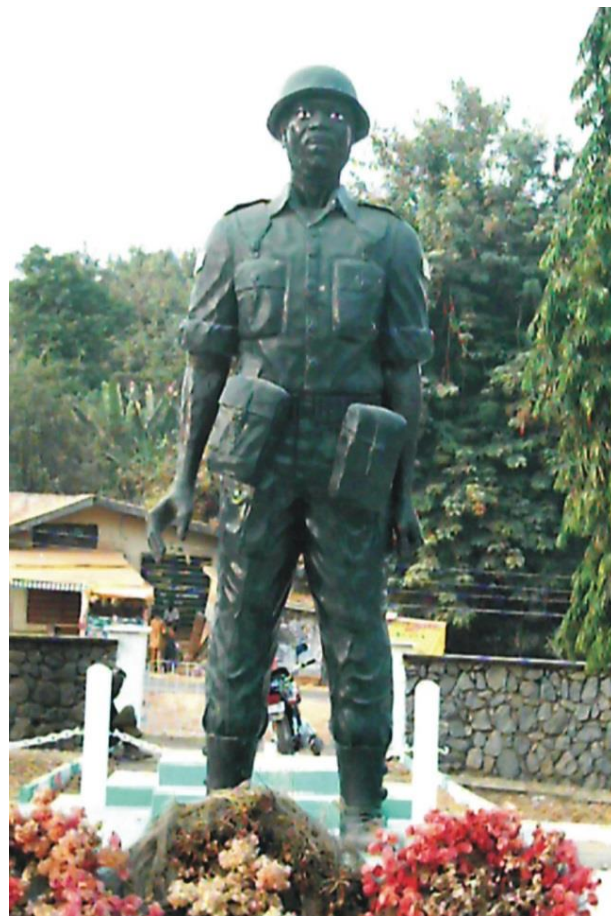
Plate 3: Trumpeter, one of the statues in Osogbo formally maintained by Osun State Capital territory Development Authority now neglected. Photograph by Moses Akintonde, 2009.

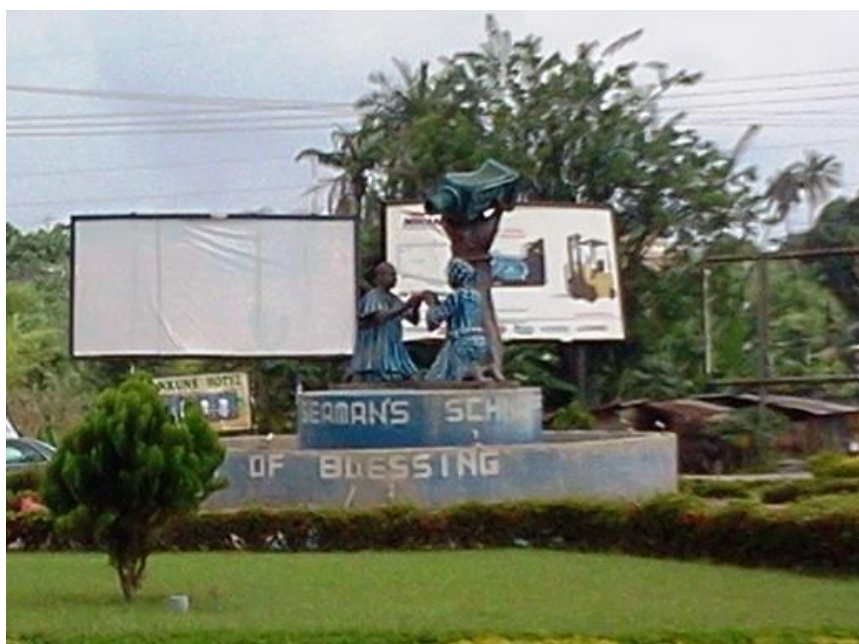
Plate 5: Seaman Schnapps advertisement outdoor sculpture; the only statue still maintained in Osogbo. Photograph by Moses Akintonde, 2014

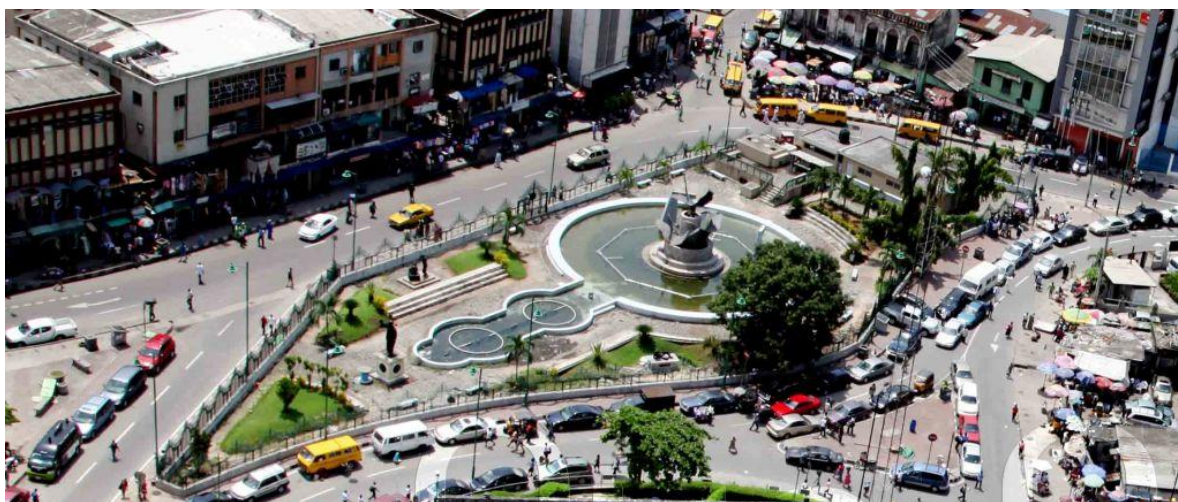
Plate 6: Aerial view of well-maintained New Tinubu Square, Lagos. Photograph by Ayo Akinyemi, 2013
